MINE-RELATED AND NATURAL ACID SEEPS AT GIBBONS CREEK LIGNITE MINE, TEXAS¹

Jan K. Horbaczewski²

¹ Paper presented at the 28th Annual Surface Mine Reclamation Workshop, College Station, Texas, October 4-5, 2007. Workshop sponsored by the Texas Cooperative Extension Service and the Texas Agricultural Experiment Station.

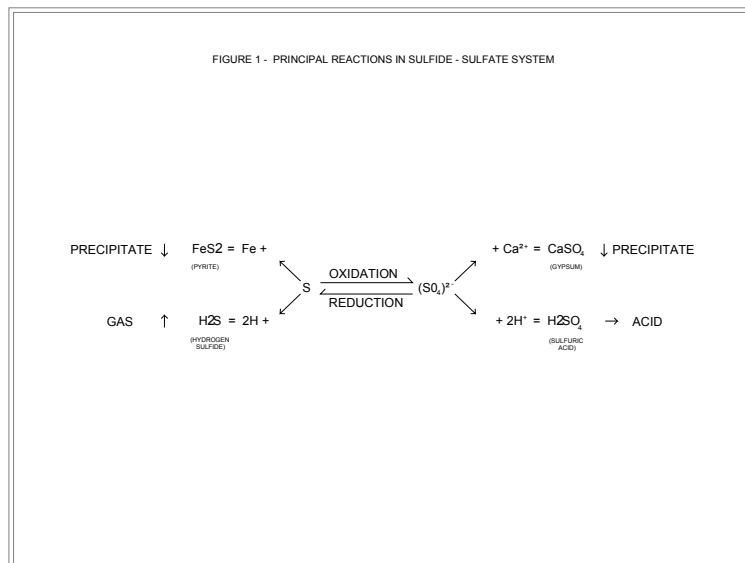
For the purposes of this discussion, the main reactions that have been discussed above may be simplified to the following form (Figure 1):

Figures 1 and 4 were drafted by Lee Ponzio, and Figure 3 by Dale Kubenka, at TMPA. The photographs were taken by the author.

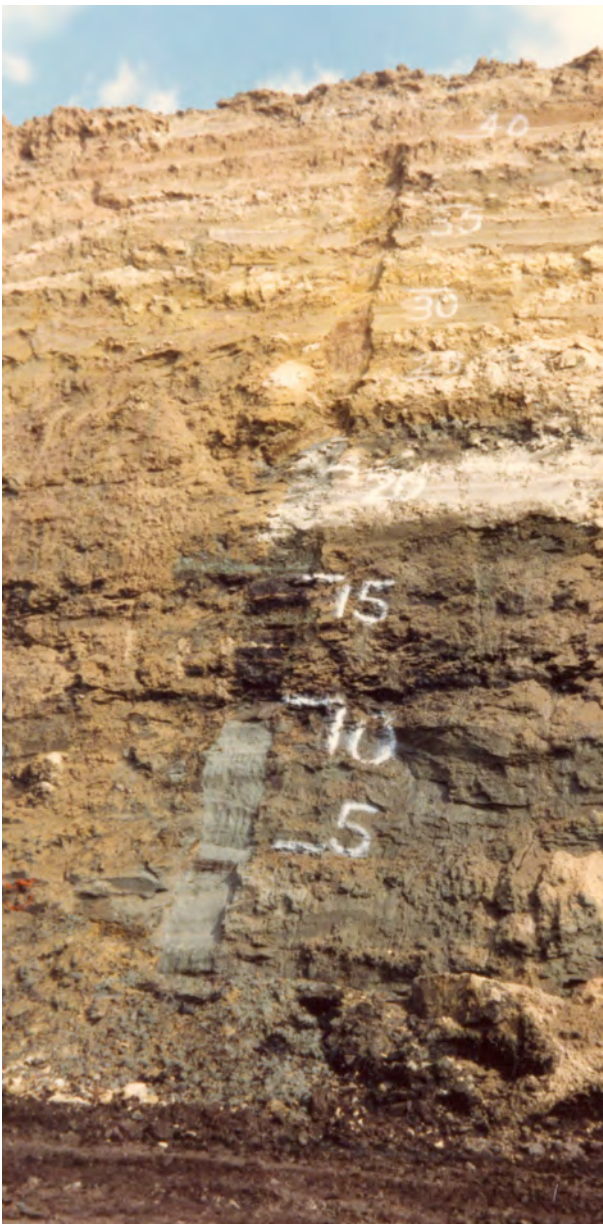
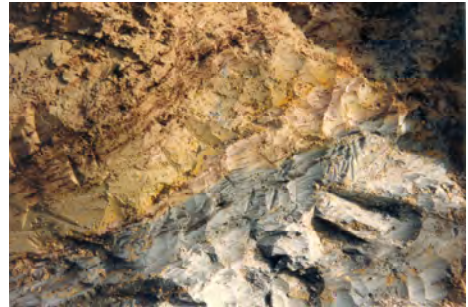
Figure 2 – Overburden profile in highwall and detail of redox boundary (numbers painted on highwall denote distance in feet above top of lignite seam)

The redox boundary should really be called the redox plane because it is a surface with a lateral extension. It generally parallels the surface topography and in dip-oriented mine pits can be seen to transgress geological units. The depth of the boundary varies according to the permeability of the overlying geological materials but ranges from 15 feet to 40 feet, with an average of about 27 feet.

The fact that the redox plane parallels the surface topography and transgresses lithological units and even displacement faults has deeper significance. It indicates that the plane is a dynamic rather than static feature. It is a feature that is continuing to migrate downwards over geological time. The fact that it occurs at a relatively constant depth (with minor variations for permeability) indicates that it is a feature that is in equilibrium with the surface. It is presumably in equilibrium with the rate of erosion of the surface over geological time – when a foot of material is eroded from the surface, the redox boundary gradually responds by migrating a foot downwards. The implications are geochemically profound. Fresh pyrite, previously protected below the redox boundary, becomes exposed to oxidation as the boundary passes over it. Thus, the natural oxidation process never ceases.

Chemical analysis of the geological materials above the redox boundary reveals additional evidence of ongoing oxidation. Pyrite is almost completely absent above the redox boundary whereas it is completely unoxidized below. The same applies to lignite seams. Above the redox boundary, they are generally degraded through oxidation. Mining does not start at the “outcrop” of lignite seams. It starts at the “subcrop” where the seams intersect the redox boundary (the exact location of subcrops has to be found by “fence drilling” across the geologist’s projection of these intersections). Other geochemical indicators of oxidation above the redox boundary are an accumulation of sulfate and a zone (or sometimes several zones) of very low pH indicating active oxidation of pyrite. The oxidized zone above the redox boundary does not necessarily signify that all the pyrite has been oxidized – just that it is an ongoing process. On the other hand, the presence of unoxidized pyrite and lignite, and the absence of sulfate accumulations confirm that oxidation reactions have not started below the redox boundary.

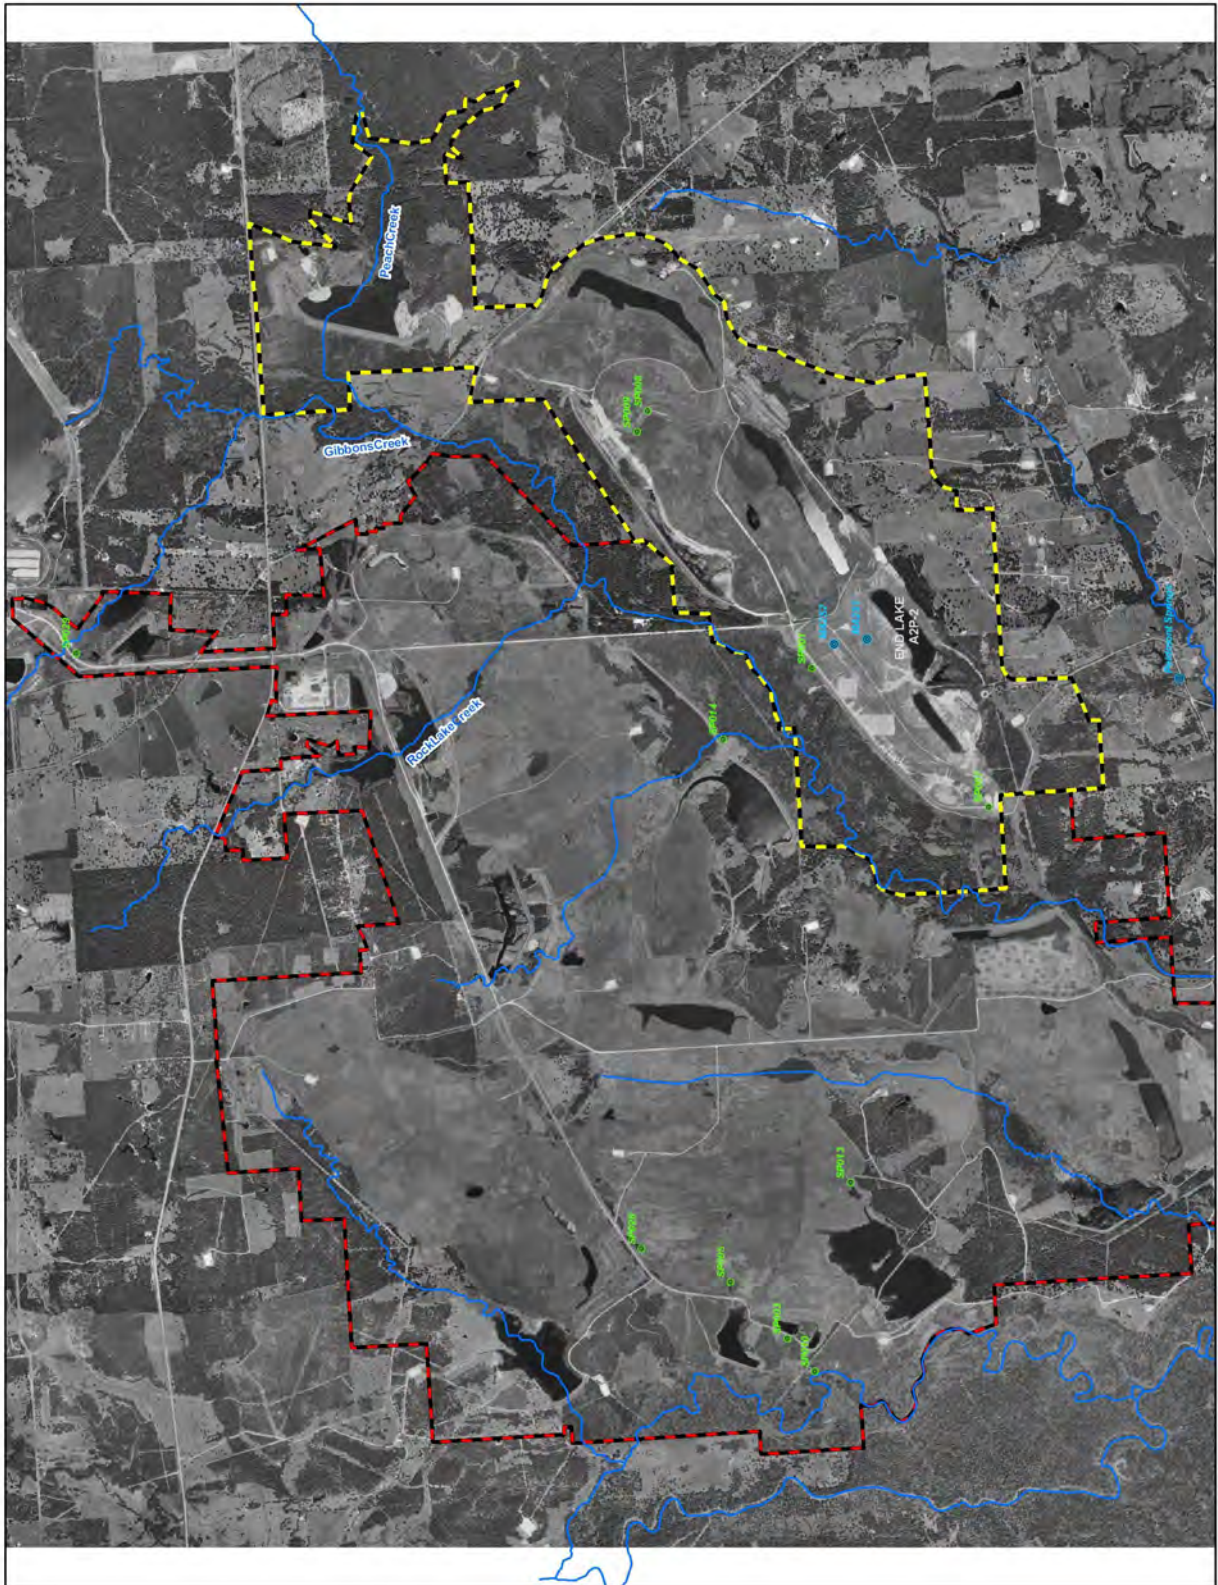
Figure 3 - Map of mine-related and natural acid seep locations at Gibbons Creek lignite mine

The Peach Creek drainage system covers an area of 5,162 acres (just over 8 square miles) east of the reclaimed Gibbons Creek mine (Figure 3). Parts of this area were to be mined so it was studied intensively for baseline conditions in the early 1990s. These studies included a water chemistry survey of Peach Creek and its tributaries. In 1995, TMPA decided to switch fuels from the relatively high-sulfur local lignite to low-sulfur “compliance” coal from the Powder River Basin in Wyoming. The Peach Creek area has therefore remained undisturbed.

The variations in pH reflect variations in base flow (Table 3). Marston Environmental, Inc. (2004) demonstrated a relationship of pH to flow for the nearby Rock Lake Creek North drainage system (just north of the Gibbons Creek mine area – Figure 3). Marston’s conclusion was that low pH values at times of base flow were due to acid seepage. The higher pH values at times of higher flow were attributed to rainfall dilution.

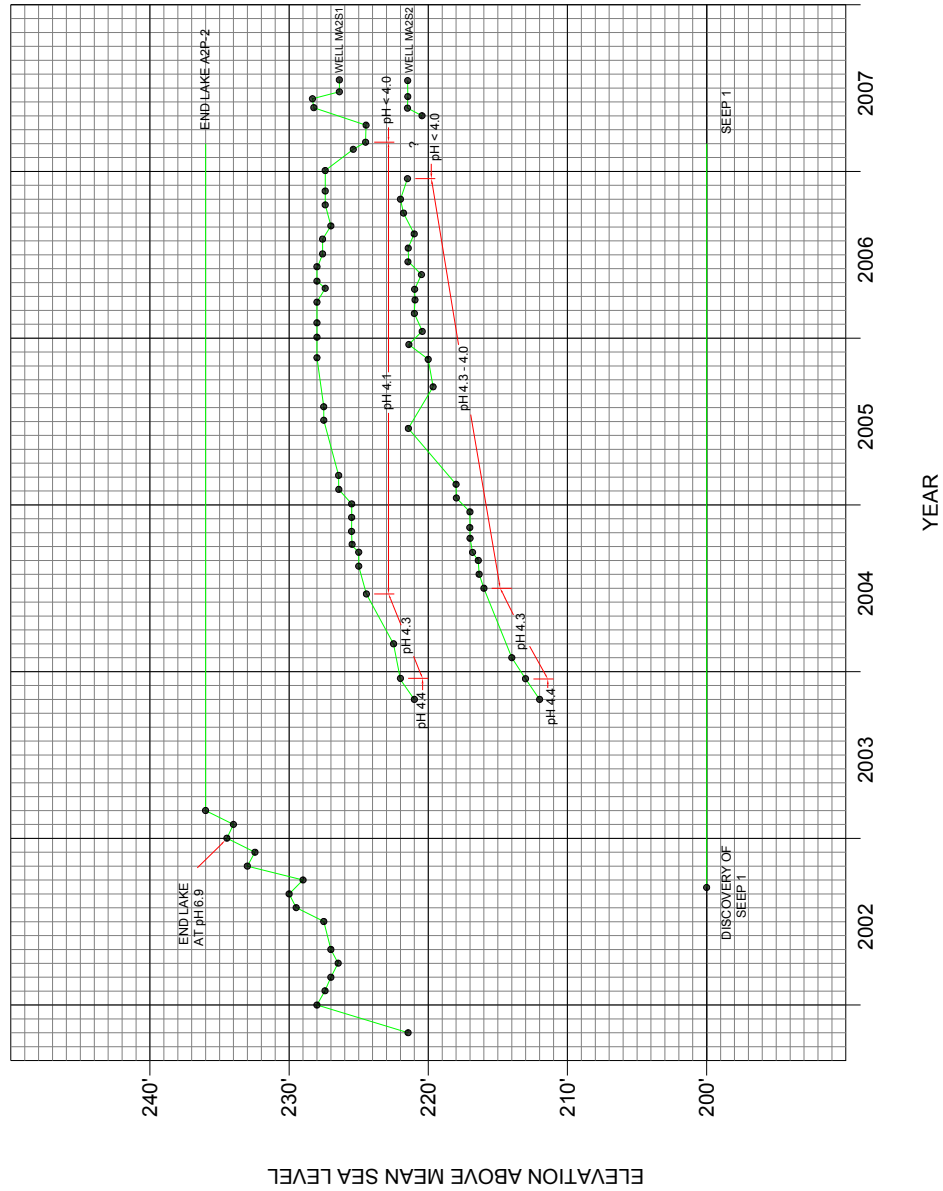
At the time Seep 1 was discovered, end lake A2P-2 was still in the process of construction and of filling with rainfall runoff (Figure 4). On September 5, 2002, end lake A2P-2 was at 229.7 feet above msl. By the end of February 2003, the end lake had reached its design elevation of 236 feet above msl. Water levels in the two spoil wells MA2S1 and MA2S2 had stabilized by the end of 2005, indicating a lag of about three years behind the end lake. The fluctuations since the end of 2005 appear to be related to seasonal effects.

FIGURE 4 - WATER LEVEL ELEVATIONS IN RELATION TO SEEP 1

Pyritic materials in the oxidizing zone above the water-table will proceed rapidly to complete oxidation. The evidence for this is the gradually falling pH of wells MA2S1 and MA2S2 (Figure 4). At the start of monitoring on September 29, 2003, both wells showed a pH of 4.4. The pH of both declined at the same rate, dropping below 4.0 at MA2S2 on December 15, 2006, and at MA2S1 on February 5, 2007. Once the supply of pyrite becomes exhausted, the production of acid will cease. In sandy materials, this will occur relatively quickly because the rate of rainfall percolation will be faster and because sandy formations represent high energy geological environments of deposition with little pyrite formation in the first place.
