THE HYDROLOGY AND GEOCHEMISTRY OF ACID SEEP 1 AT GIBBONS CREEK LIGNITE MINE, TEXAS¹

Jan K. Horbaczewski²

¹ Paper presented at the 33rd Annual Surface Mine Reclamation Workshop, College Station, Texas, October 4-5, 2012. Workshop sponsored by the Texas Cooperative Extension Service and the Texas Agricultural Experiment Station.

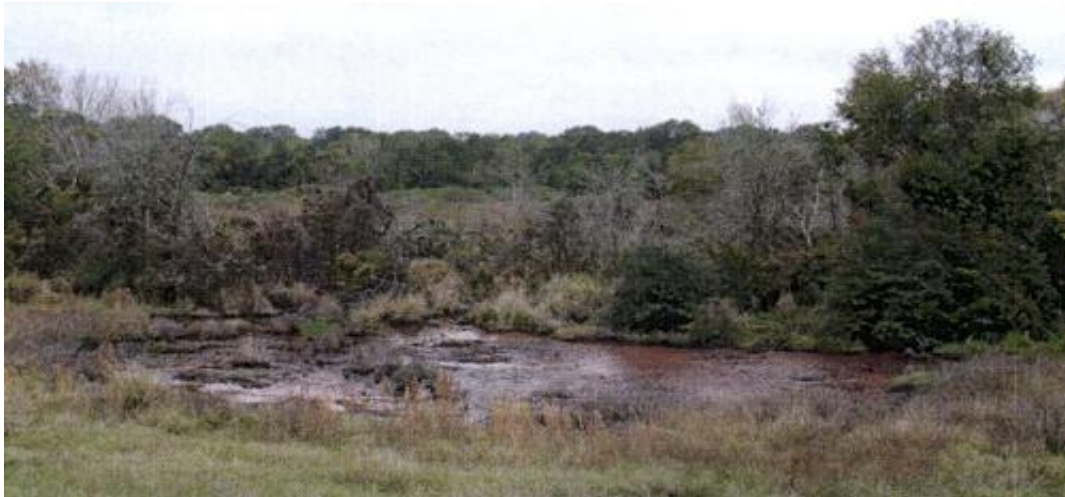
Seep 1, in its original condition before it was mitigated in 2011, occupied approximately 0.3 acres (Figure 1). The site is located at the toe of the A2 Mine Block boxcut spoil (at 3,335,785 E and 348,258 N, Texas Central State Plane coordinates, North American Datum 1927; or 30.55°N and 96.09°W, UTM). The boxcut spoil represents the location of the first dragline pits in the A2 Mine Block. The seep is at the edge of the Gibbons Creek floodplain at an elevation of approximately 200 feet above mean sea level (m.s.l.) At the time of its discovery it was flowing at about 0.5-1 gallons per minute (gpm), had a pH of 2.8-3.5, and rust-colored deposits of hydrated iron oxides.

Figure 1 – Seep 1 looking north (November 15, 2004)

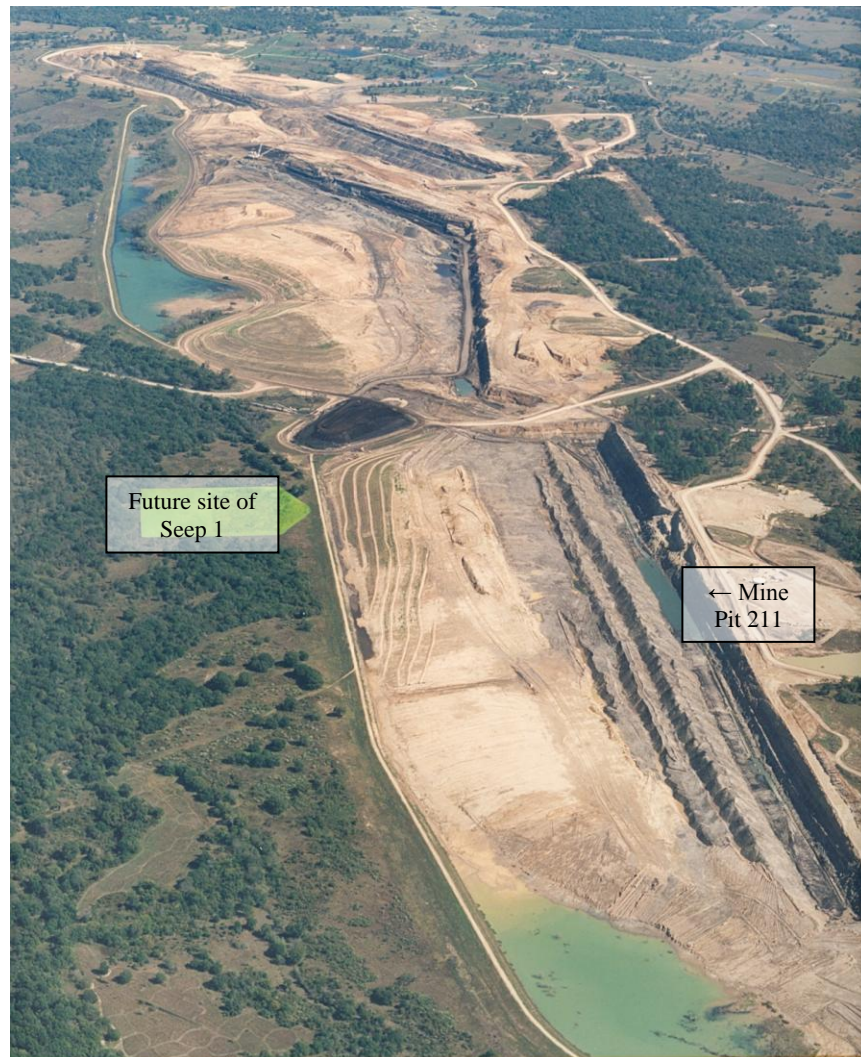
Figure 4 – A2 and A3 Mine Blocks (April 1994)

The photograph shows A2 Mine Block in the foreground and A3 Mine Block in the background. The temporarily abandoned Pit 211 with two ungraded spoil ridges marking the former locations of Pits 210 and 209 is visible in the A2 Mine Block. Very little remains of Pit 208 – the ridge that marked its location has been leveled along most of its length. The regraded, gray-colored (reduced) spoil of previous mine pits is obscured by a four-foot cover of tan-colored (oxidized), non-pyritic overburden that was spread with mobile equipment. This material was then planted with permanent vegetation visible as green strips separated by erosion control terraces. At the bottom of the slope is the future location of Seep 1.

Other features of interest in the photograph include: the sedimentation pond controlling runoff from the A2 Mine Block (area of green water in the foreground); the black lignite stockpile in the middle distance; and the two draglines in the A3 Mine Block (one working from the spoil side at the far end of the chevron pit and the other working from the highwall side at the very far end of the most distant pit). Mining in the A2 Block resumed in 1995 when one of the draglines returned. Removal of coal from Pit 217 was completed a few months after both draglines were parked on February 29, 1996 and the pit was abandoned.

Initially, the rate was fast – the pits were short and the overburden shallow. But by 1993 the rate had begun to slow. This was partly due to the geometry of the mine block which allowed the pits to become lengthened and partly due to the overburden cover becoming thicker. The geological dip meant that each pit was about three feet deeper than the previous one and the topography of the ground surface started rising because the dragline was advancing into a hill. In 1994, there was a temporary cessation of mining when the dragline was moved to assist operations in the A3 Mine Block (Figure 4).

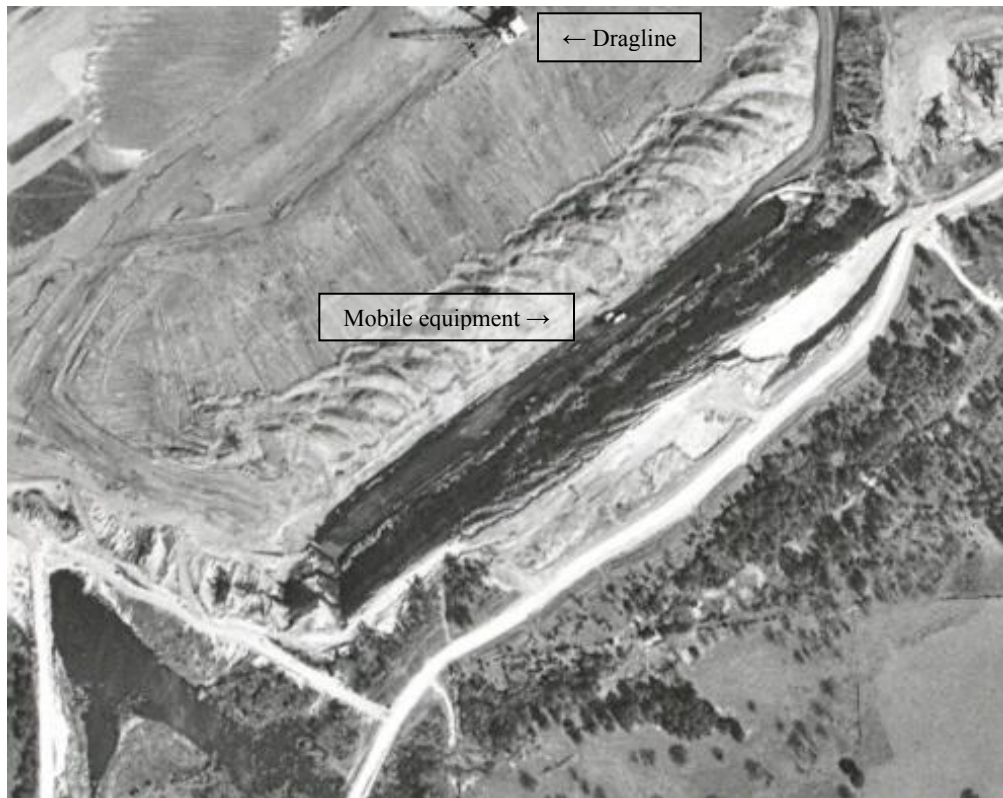
Figure 5 – Aerial photograph of Pit 217 on March 8, 1996

In some digging scenarios, the dragline left additional topographic features, such as the arcuate, en echelon ridges superimposed on the main spoil ridge (see Figures 5 and 6) that further helped to trap rainfall and enhance infiltration.

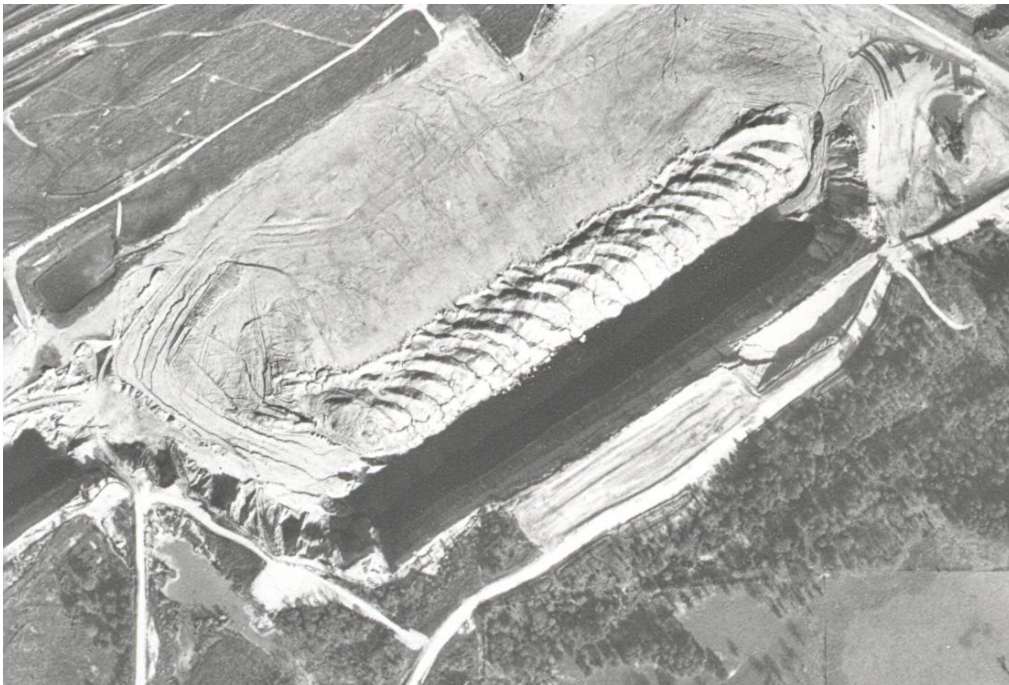
Figure 6 – Aerial photograph of Pit 217 on December 13, 1996

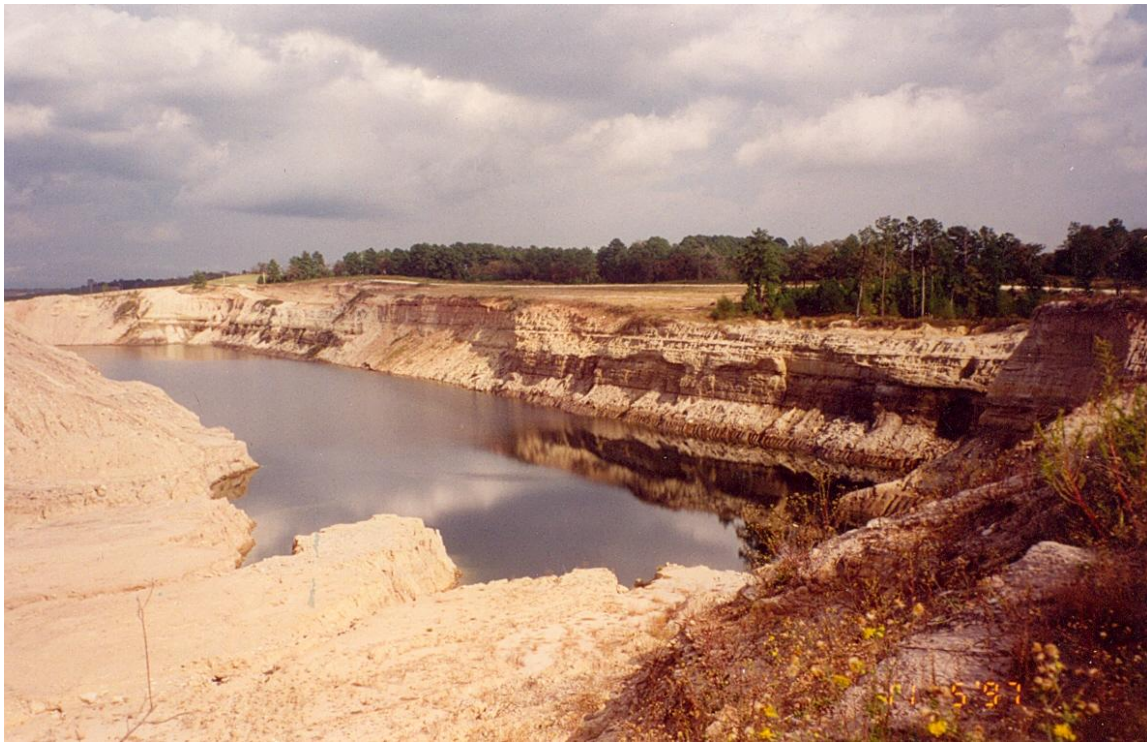
Figure 7 – Mine Pit 217 on November 5, 1997 (view from southwest)

Groundwater levels in the spoil started being measured in the two spoil wells in September 2003. Levels before that time have been inferred from correlation with water levels in Pit 217. On March 8, 1996 Pit 217 was dry and mobile equipment was still removing the last of the coal in the bottom (Figure 5). The dragline had stopped stripping overburden and can be seen parked north of the pit. By December 13, 1996 there were already several feet of water in the bottom of the pit (Figure 6), and less than two years after mining had stopped the pit had filled significantly (Figure 7).

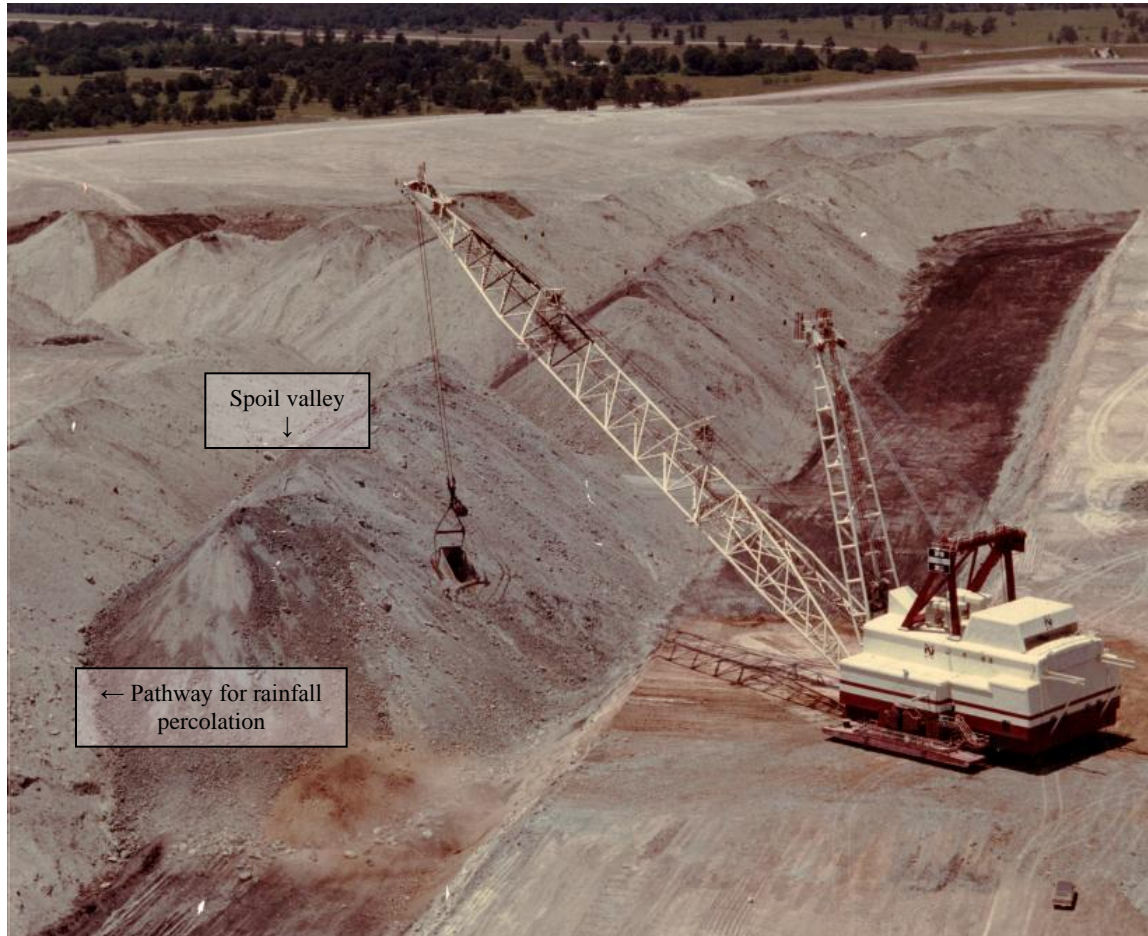
The dragline dumped spoil in the form of long “ridges” and “valleys” parallel to the mine pit (Figure 10). As the loose spoil fell out of the dragline bucket onto the ridge, large boulders rolled down the ridge slopes to collect in a line along the interface with the previous ridge. The size of some of these boulders may be

compared to the Suburban visible in the bottom right-hand corner of the photograph. As the dragline progressed along the pit, these lines coalesced to form a continuous sub-vertical plane of large boulders providing a pathway for rainfall percolation. Any rainfall trapped between the spoil ridges would be channeled along the spoil valleys to these pathways.

Figure 10 – Typical Highwall-Side Dragline Operation

Photograph: Aero Views, Mine Block B2, c. 1984 (note Suburban for scale in bottom right-hand corner).
