MINE-RELATED AND NATURAL ACID SEEPS AT GIBBONS CREEK LIGNITE MINE, TEXAS¹

Abstract

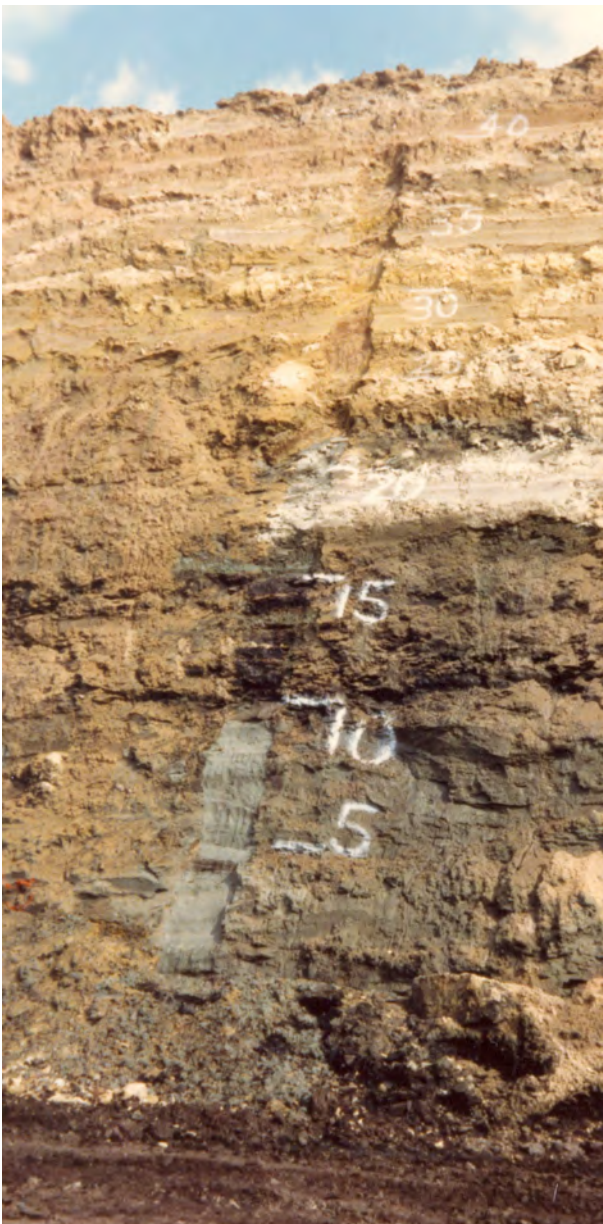
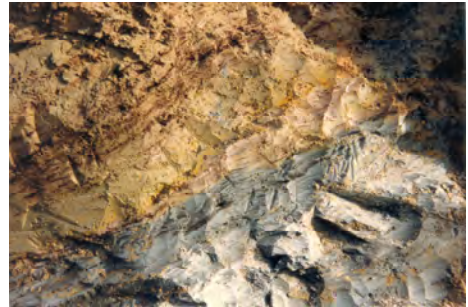
Figure 2 – Overburden profile in highwall and detail of redox boundary (numbers painted on highwall denote distance in feet above top of lignite seam)

The redox boundary should really be called the redox plane because it is a surface with a lateral extension. It generally parallels the surface topography and in dip-oriented mine pits can be seen to transgress geological units. The depth of the boundary varies according to the permeability of the overlying geological materials but ranges from 15 feet to 40 feet, with an average of about 27 feet.

The fact that the redox plane parallels the surface topography and transgresses lithological units and even displacement faults has deeper significance. It indicates that the plane is a dynamic rather than static feature. It is a feature that is continuing to migrate downwards over geological time. The fact that it occurs at a relatively constant depth (with minor variations for permeability) indicates that it is a feature that is in equilibrium with the surface. It is presumably in equilibrium with the rate of erosion of the surface over geological time – when a foot of material is eroded from the surface, the redox boundary gradually responds by migrating a foot downwards. The implications are geochemically profound. Fresh pyrite, previously protected below the redox boundary, becomes exposed to oxidation as the boundary passes over it. Thus, the natural oxidation process never ceases.

Chemical analysis of the geological materials above the redox boundary reveals additional evidence of ongoing oxidation. Pyrite is almost completely absent above the redox boundary whereas it is completely unoxidized below. The same applies to lignite seams. Above the redox boundary, they are generally degraded through oxidation. Mining does not start at the “outcrop” of lignite seams. It starts at the “subcrop” where the seams intersect the redox boundary (the exact location of subcrops has to be found by “fence drilling” across the geologist’s projection of these intersections). Other geochemical indicators of oxidation above the redox boundary are an accumulation of sulfate and a zone (or sometimes several zones) of very low pH indicating active oxidation of pyrite. The oxidized zone above the redox boundary does not necessarily signify that all the pyrite has been oxidized – just that it is an ongoing process. On the other hand, the presence of unoxidized pyrite and lignite, and the absence of sulfate accumulations confirm that oxidation reactions have not started below the redox boundary.

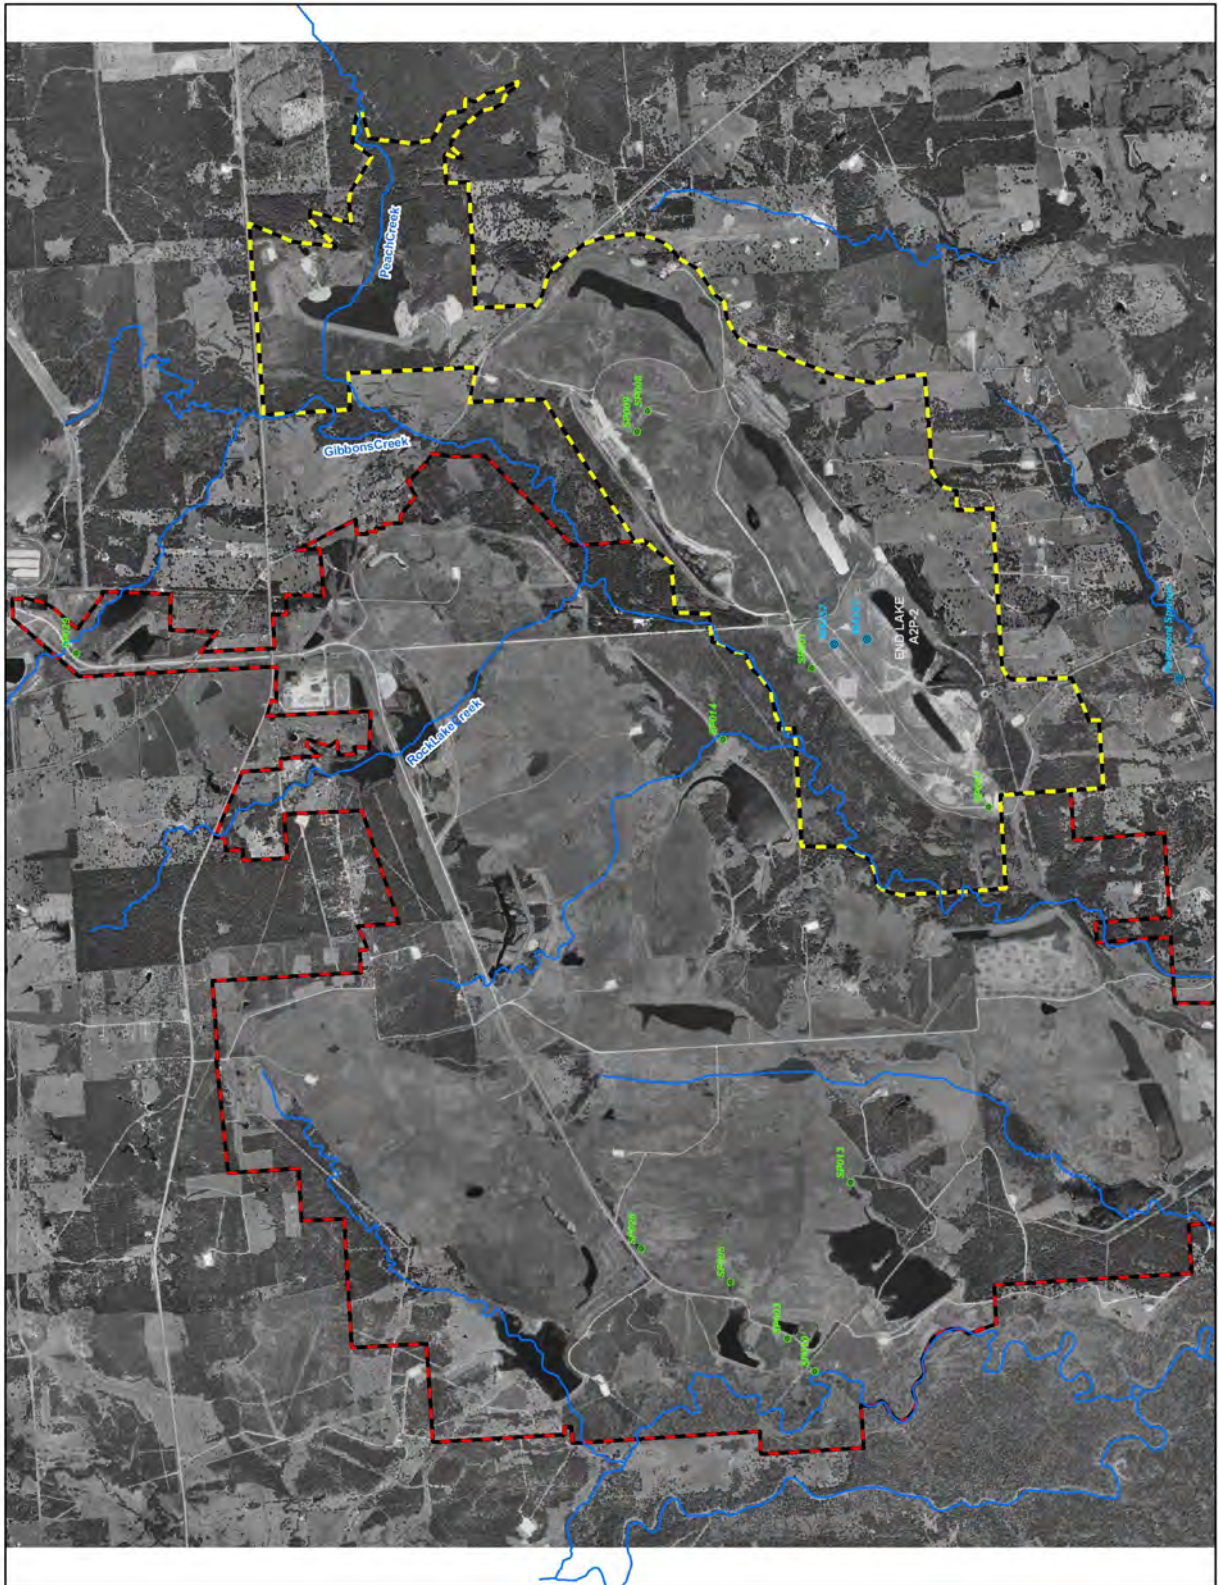
Figure 3 - Map of mine-related and natural acid seep locations at Gibbons Creek lignite mine

The Peach Creek drainage system covers an area of 5,162 acres (just over 8 square miles) east of the reclaimed Gibbons Creek mine (Figure 3). Parts of this area were to be mined so it was studied intensively for baseline conditions in the early 1990s. These studies included a water chemistry survey of Peach Creek and its tributaries. In 1995, TMPA decided to switch fuels from the relatively high-sulfur local lignite to low-sulfur “compliance” coal from the Powder River Basin in Wyoming. The Peach Creek area has therefore remained undisturbed.

The variations in pH reflect variations in base flow (Table 3). Marston Environmental, Inc. (2004) demonstrated a relationship of pH to flow for the nearby Rock Lake Creek North drainage system (just north of the Gibbons Creek mine area – Figure 3). Marston’s conclusion was that low pH values at times of base flow were due to acid seepage. The higher pH values at times of higher flow were attributed to rainfall dilution.
